ENGINEERING GEOLOGY OF THE  
DEVILS GATE SCHEME, TASMANIA

S. J. Paterson, B.Sc.  
(non-member)\*

Summary

The geological situation and the foundation and abutment conditions are described. Discussed are the problems arising from the presence of free graphite on bedding and joint planes, the presence of the upstream edge of a large exfoliation shell within part of the right abutment, and the presence of a fault block adjacent to the upper left abutment. The scheme was completed in September, 1969.

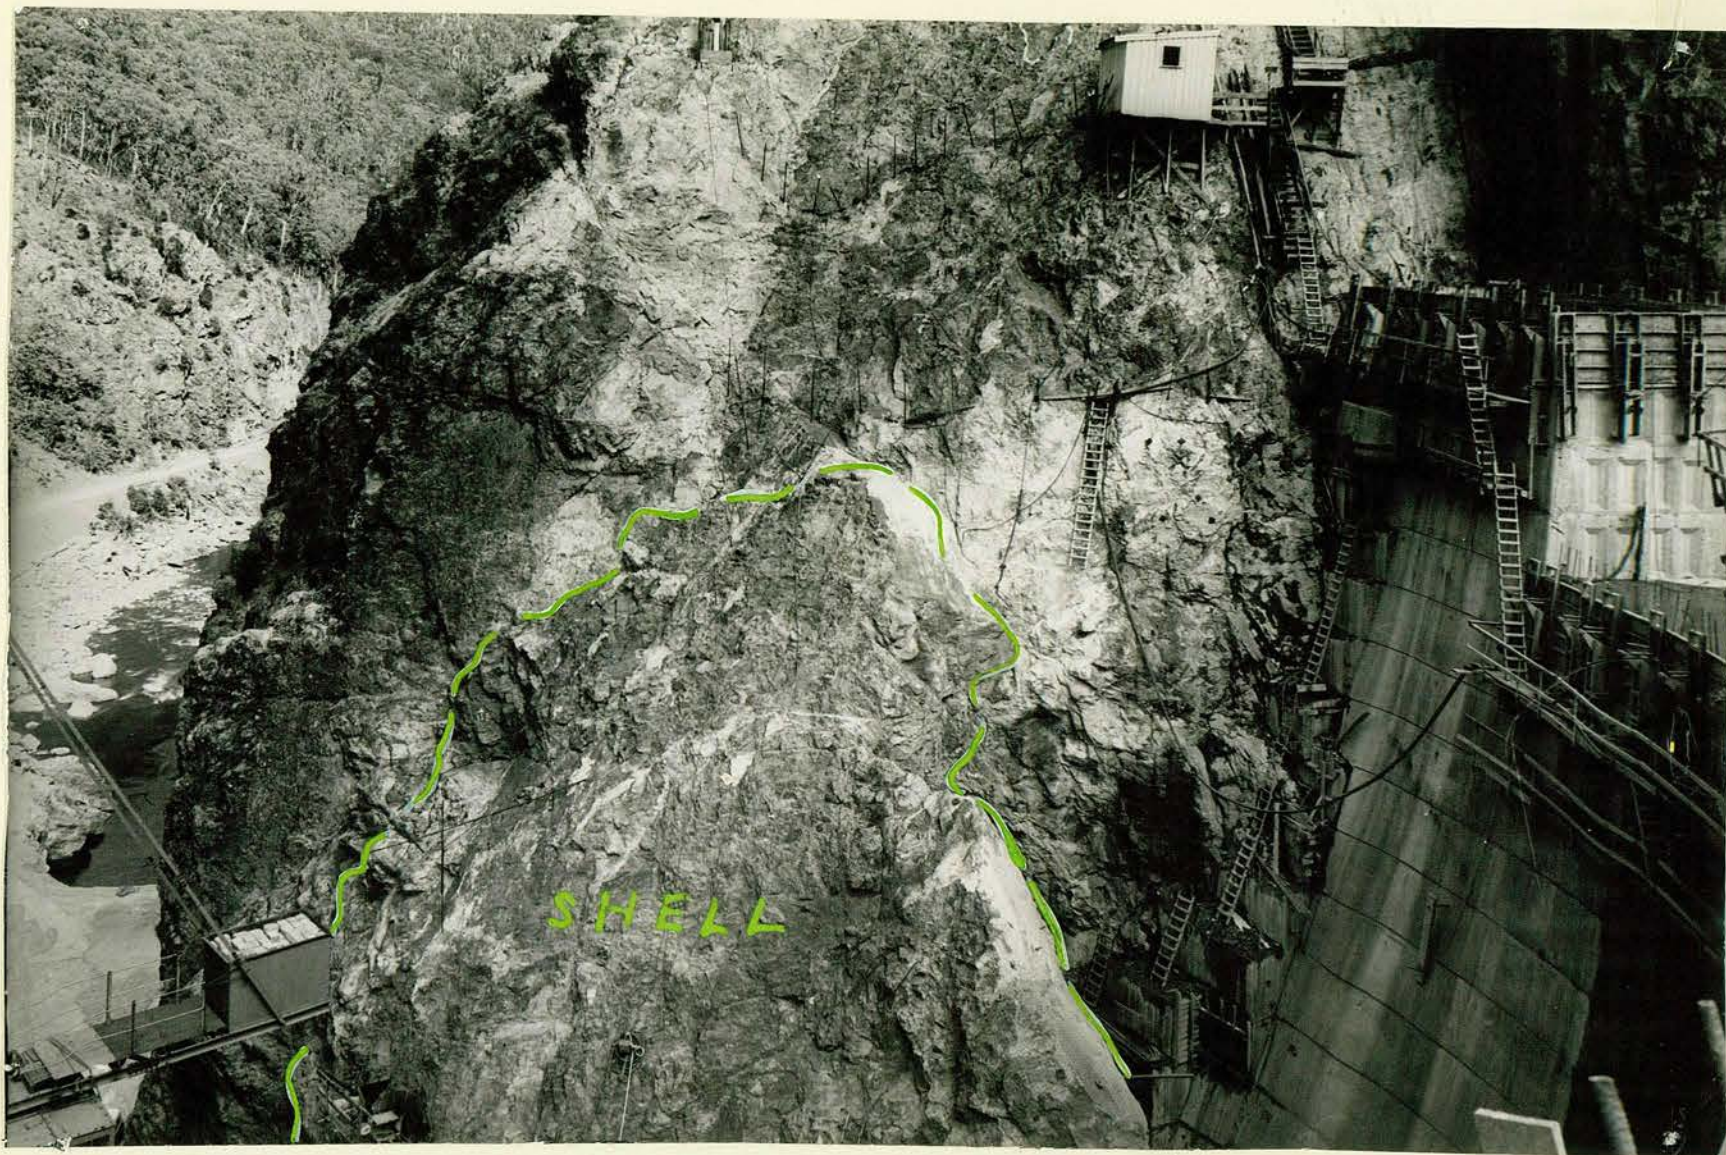
Intense micro-fault, joint and incipient fracture patterns exist throughout the rock. The micro-faults have thinly brecciated surfaces and numerous small cavities. On the right abutment major stress relief cracking parallel to the river valley has occurred and large shells of rock (Plate 2) have separated from the valley walls.

In the upper part of the abutment fresh, hard grey and fawn chert are dominant, but considerable excavation was necessary between SL200 and SL310 to remove the upstream edge of a large "onion skin" shell of rock (Plate 2 and Figure III) that extended into the abutment area. The shell rests on a base 120 ft. long and is separated from the valley walls by tension cracks that extend from river bed level at SL175 to SL310. Between SL200 and SL240 the shell has an average thickness of 30 ft. The tension cracks contain infillings of surface material, brown to black plastic clay and rock chips up to 6 in. in thickness. Adits 6 and 7 (Figure IV) were driven along the crack at SL200 and SL240 respectively to define the extent of the shell. These adits were subsequently driven into the abutment to investigate the nature of the country within the abutment. The shell has been attributed (Ref. 4) to stress relief cracking parallel to the valley. Wolters (Ref. 5) has stated that rock deformation due to unloading by natural excavation is far too small to form shells of this size. He explains such phenomena as being the result of temperature changes.

PLATE .2. Part of the right abutment showing the upper limit of the "onion" skin shell of rock immediately downstream of the dam and the slot cut to take the dam behind the shell.

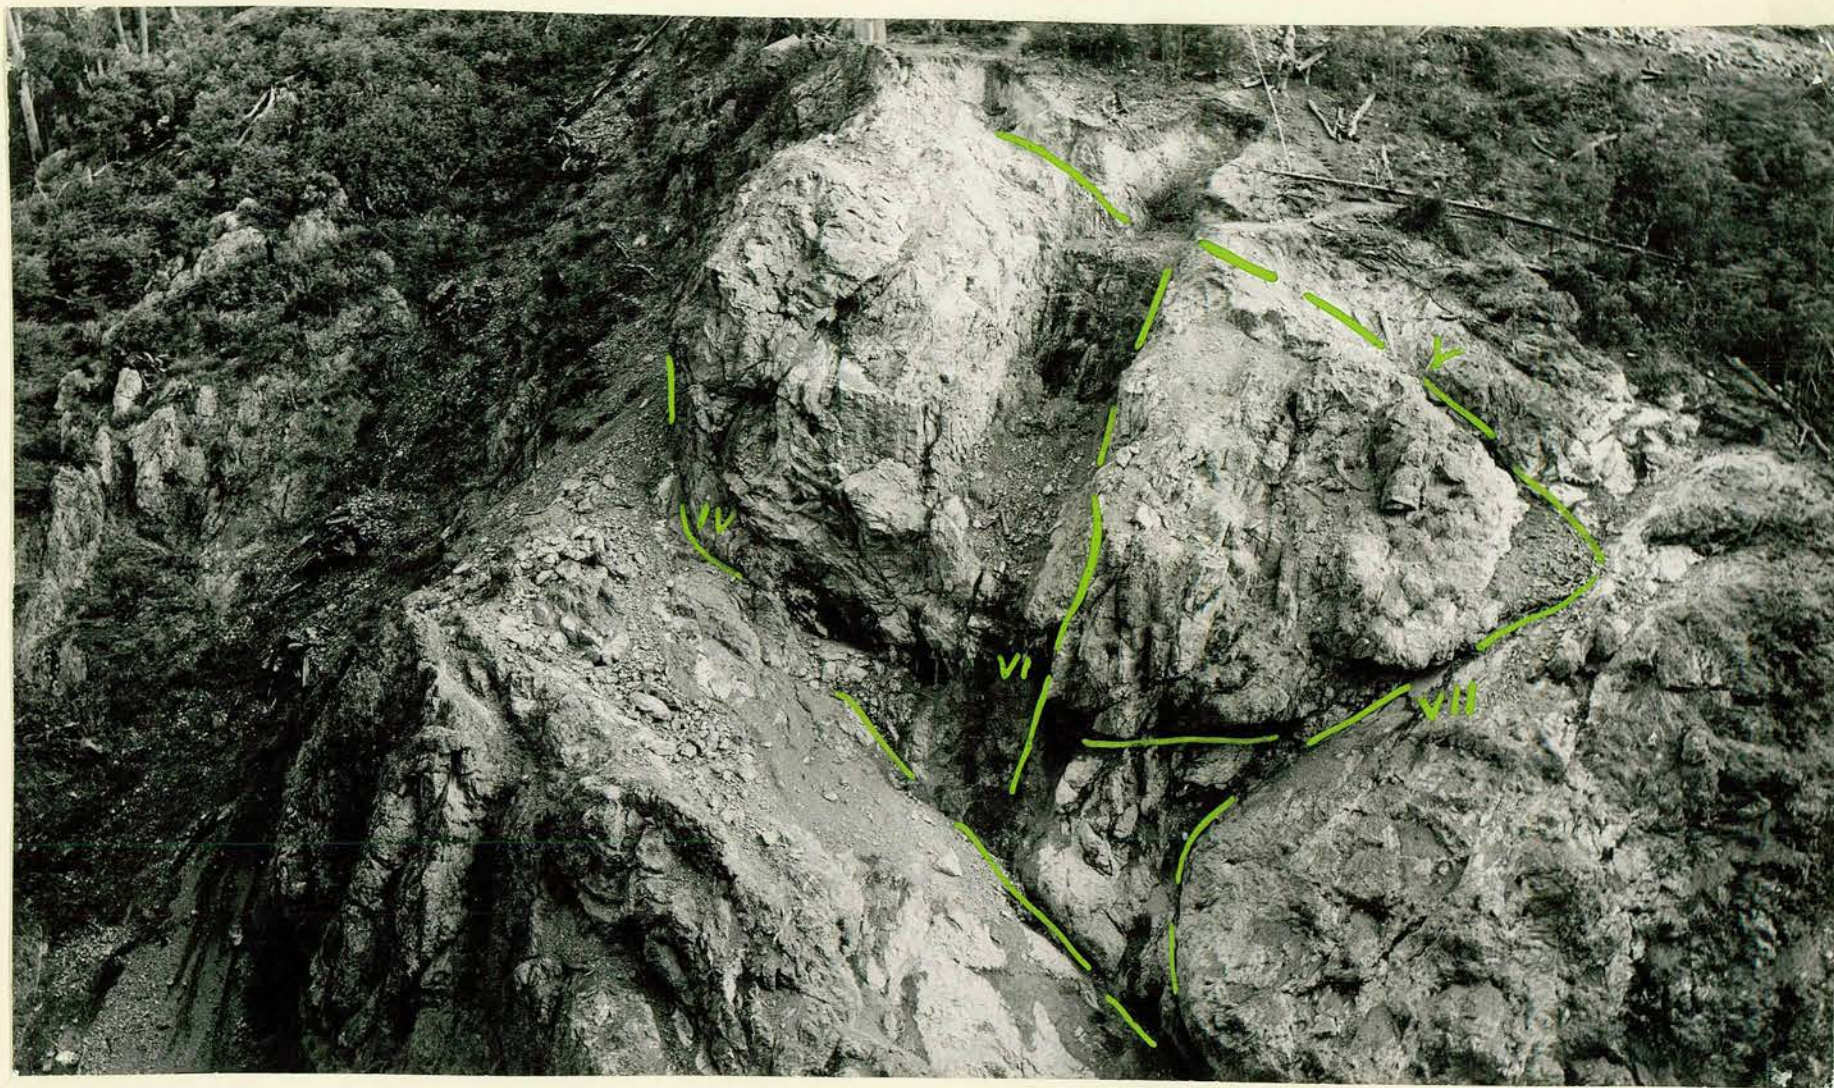
Above SL307 the abutment lies adjacent to a fault block (Plate 3) bounded by Faults V, VI and VII. The fault zones have up to 3 in. of weathered breccia and up to 3 in. of rock flour. The area was the subject of a stability analysis and as a result of this a comprehensive drainage system was designed to improve the stability of this part of the abutment.

PLATE .3. The upper left abutment during excavation showing the abutment slot and the fault wedge immediately downstream of the abutment.
