Date	Author	Report N ^o
Cethana Damsite.	1965.	G. Hale.	644-Ceth-1.
Detailed Geol. Invest of the left Abutment of Cethana Damsite.	8/9/65	G. Rawlings.	-
Detailed Geol. Invest. of the <u>Right</u> Abutment of Cethana Damsite	8/9/65	G. Rawlings	-
Seismic Determination of Young's Modulus & Poissons Ratio at Cethana Dam Site.		P.W. McDowell.	644-126-2.
Minutes of Design Conference on Cethana Dam. Dec. 1965.	22/12/65.		-
Cethana Rockfill Quarry.	25/11/66.	G.E. Rawlings.	644-126-4.
Cethana Rockfill Quarry.	12/12/66	N. Boughton.	
also Cethana Rockfill: memo 5/12/66	to Fitzpatrick.		
Cethana Rockfill Quarry.	15/6/67	N. Boughton.	
Explanatory notes to Prelim. Outline Geological map of Cethana Quarry Site.		SSP.	FILED Sept. 4 th
Cethana Quarry Investigations.	2/8/67	G.E.R.	-
Cethana Quarry Stripping Progress Report.		N.H.H.G.	Filed Sept. 29 th '67
Cethana Quarry. Memo of J.R. Neall to Planning Eng.	13/10/67	N.H.H.G.	Filed 9 th Nov. '67

CETHANA QUARRY

- Memo of J.R. Neall
To Planning Engineer.

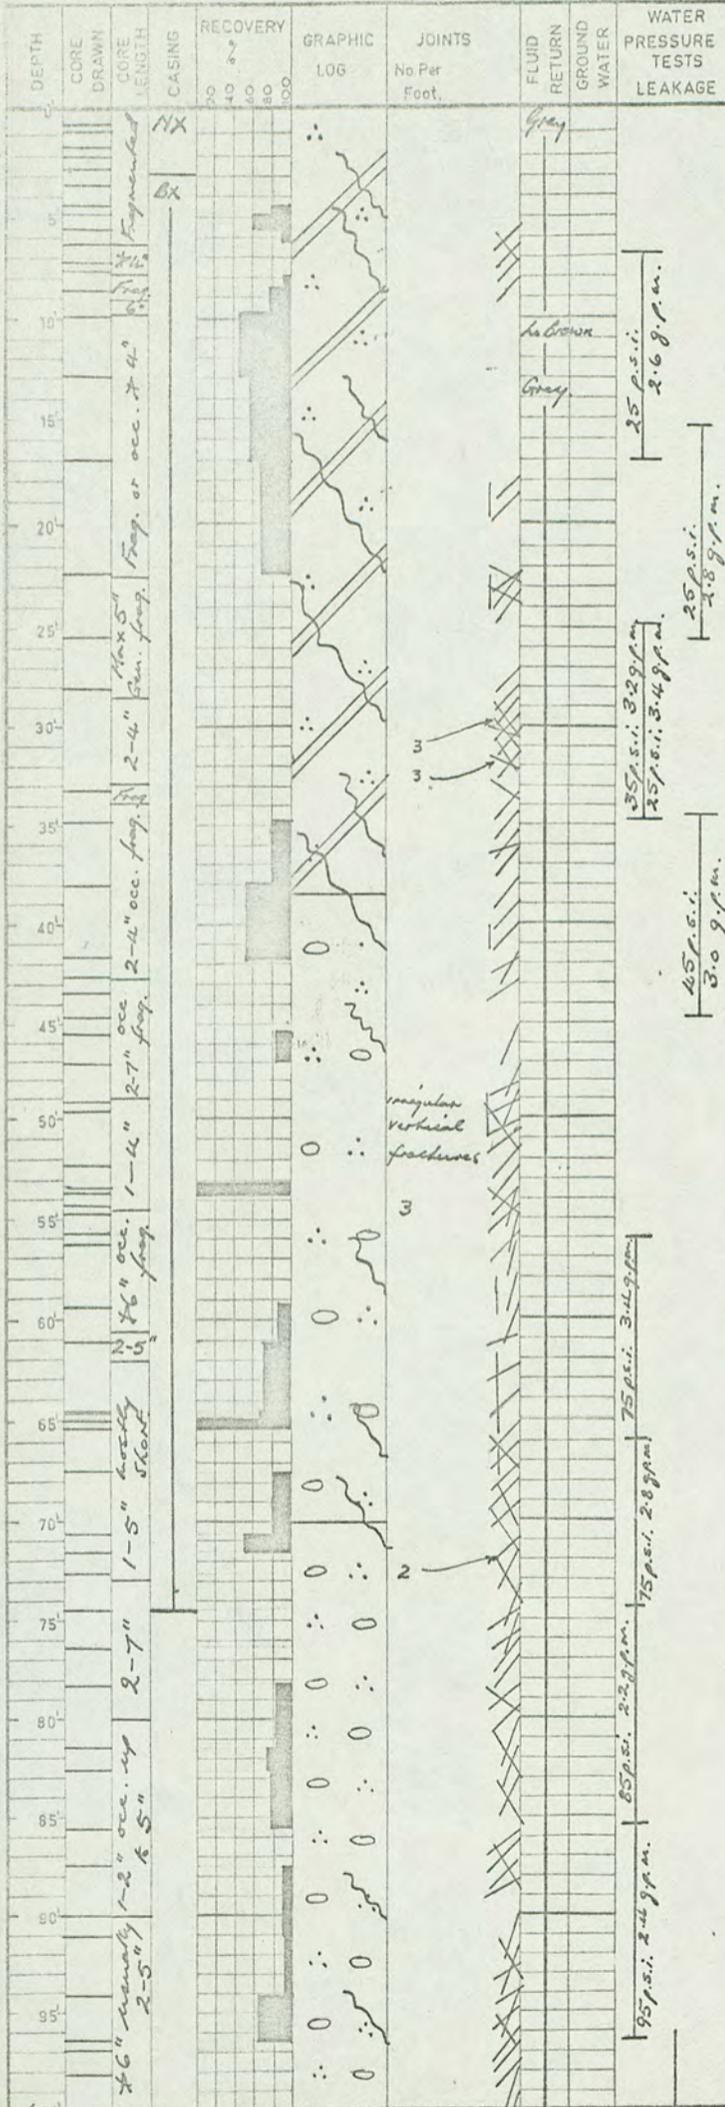
0-38'6" light grey, weathered, well jointed quartzite. Rock generally much broken up, occasionally completely fragmented. Quartz veins occasionally present, pyrites common. Joints generally open and weathered, occasionally tight.

38'6"-70' Irregularly fractured and broken quartz conglomerate and quartzite showing 'craggy' appearance. Pyrite veins and fillings common, dark filling to irregular fractures associated with them. Joints generally open and weathered but also tight and/or sealed. Quartz veins very common often grading into quartzite. Pebbles often obscured by recrystallization.

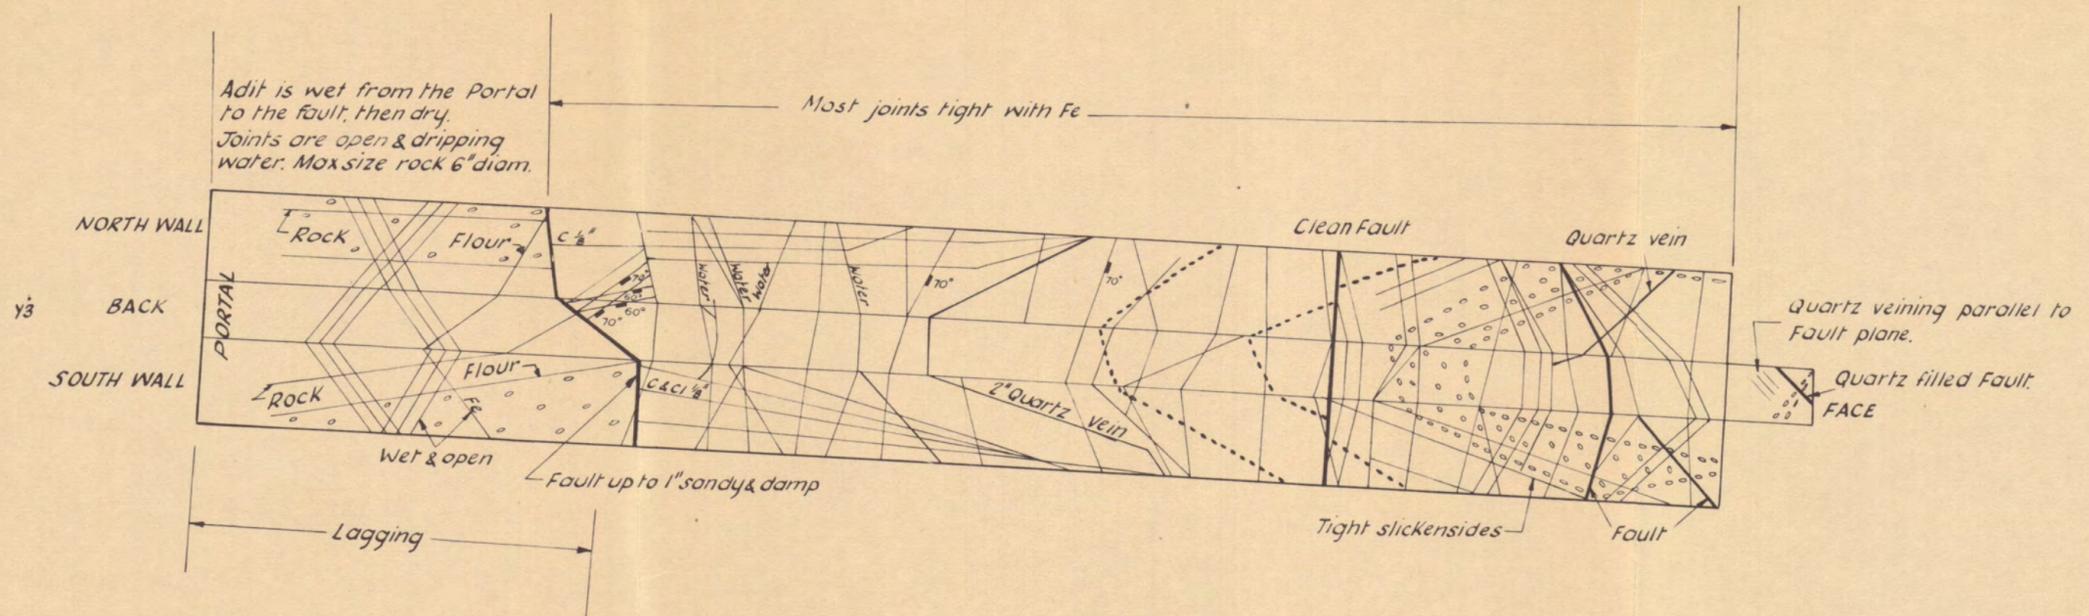
To accompany Geological Report 644-126-1		THE HYDRO-ELECTRIC COMMISSION TASMANIA					
		MERSEY FORTH POWER DEVELOPMENT CETHANA PLAN OF EXPLORATORY ADIT No.2					
Plotted	B.W.H.	Traced	B.W.H. 10/11/64	Checked	G.E.H.	SCALE	
Geologist: G. Hale			Geologist in Charge: G. Hale		10 Feet to 1 Inch		
Reference		C4991

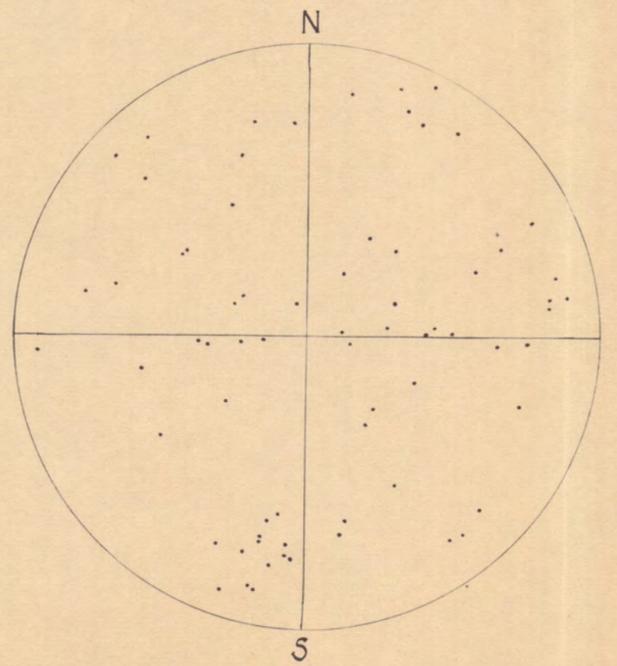
Stereogram of joint-systems at Cethana damsite. Readings taken from eight locations.

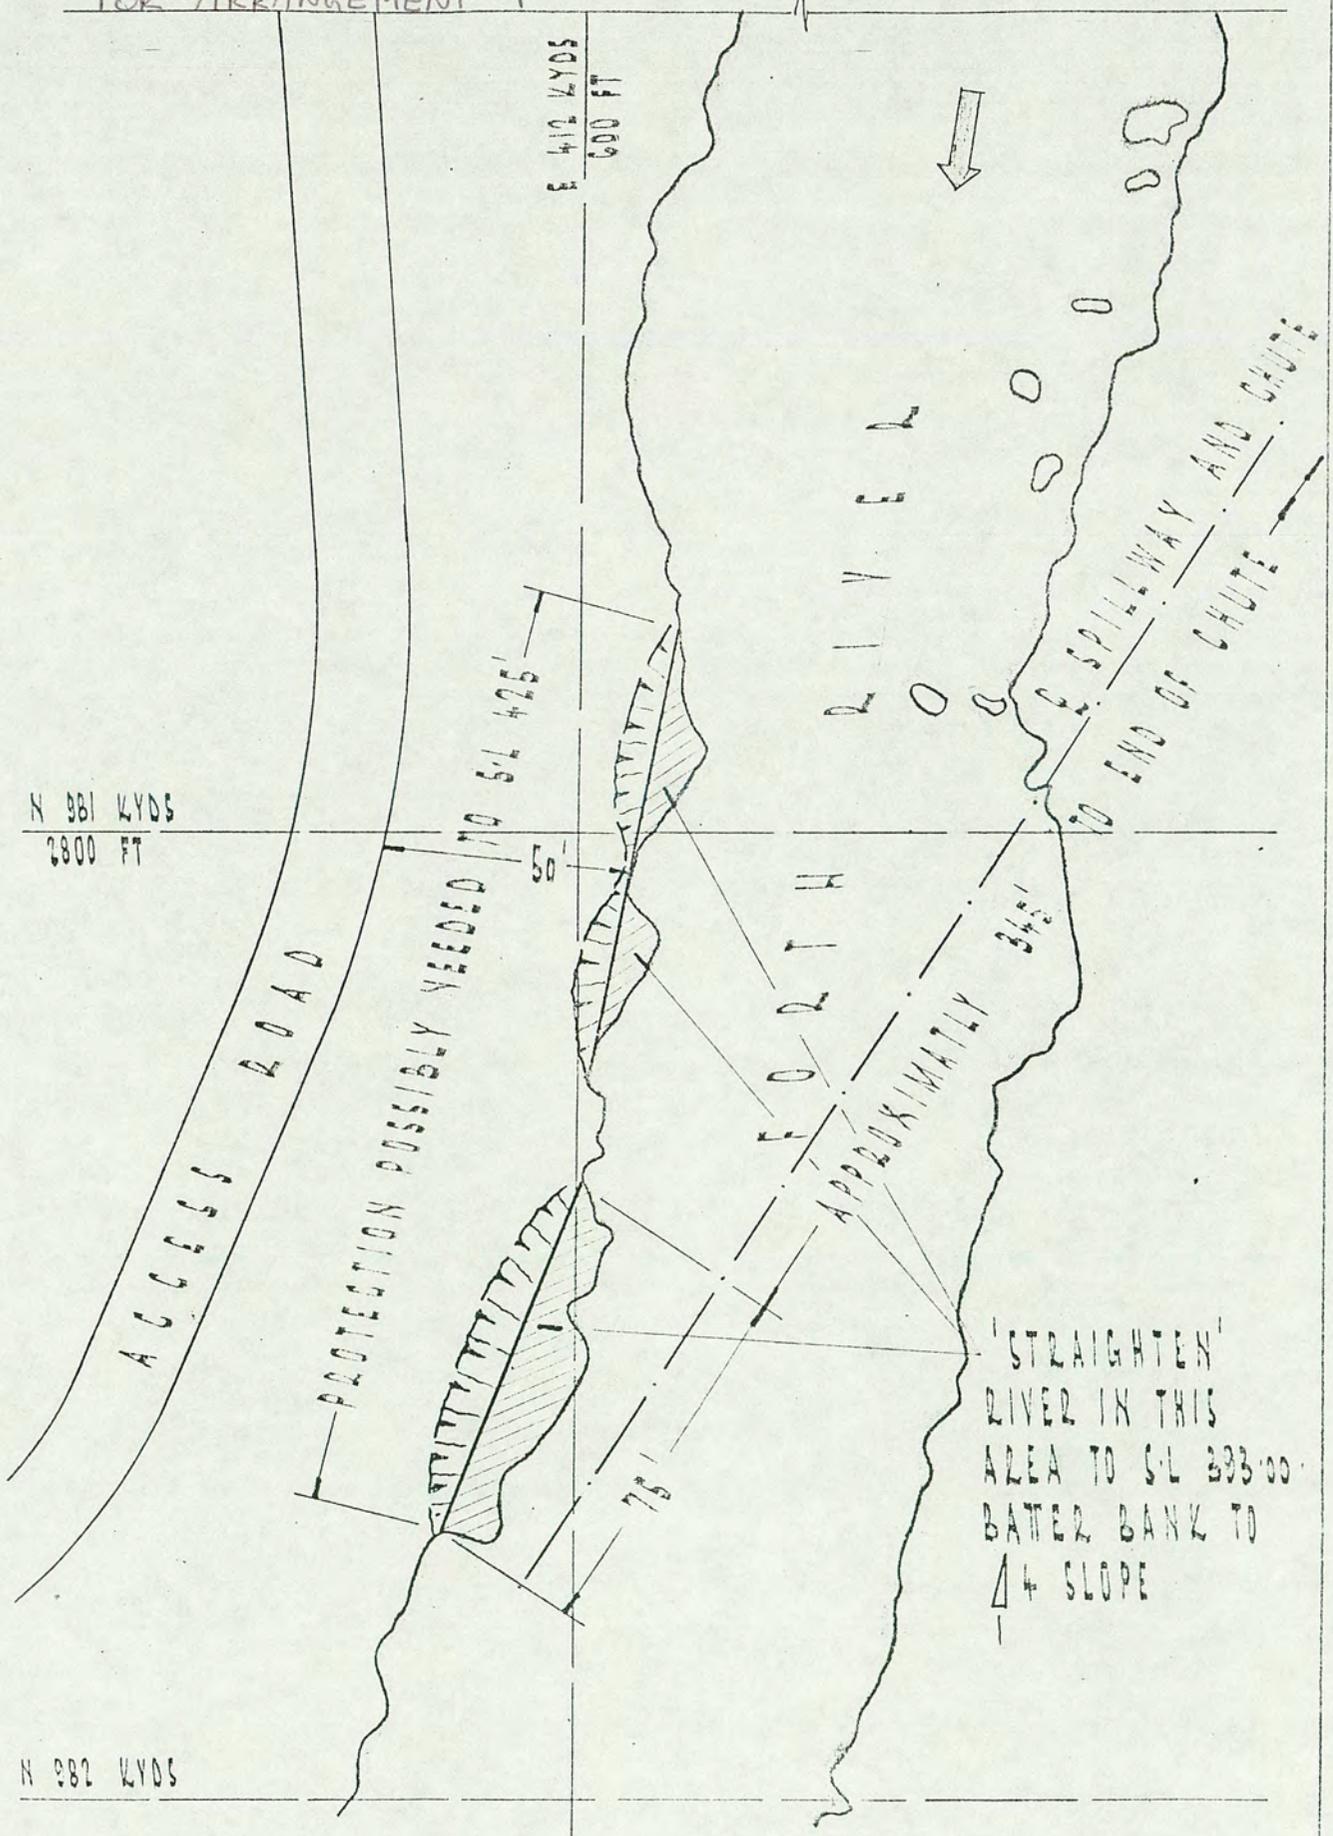
CETHANA DAM SPILLWAY
MODEL STUDIES

FOR ARRANGEMENT 4

EXCAVATION IN JET IMPACT AREA

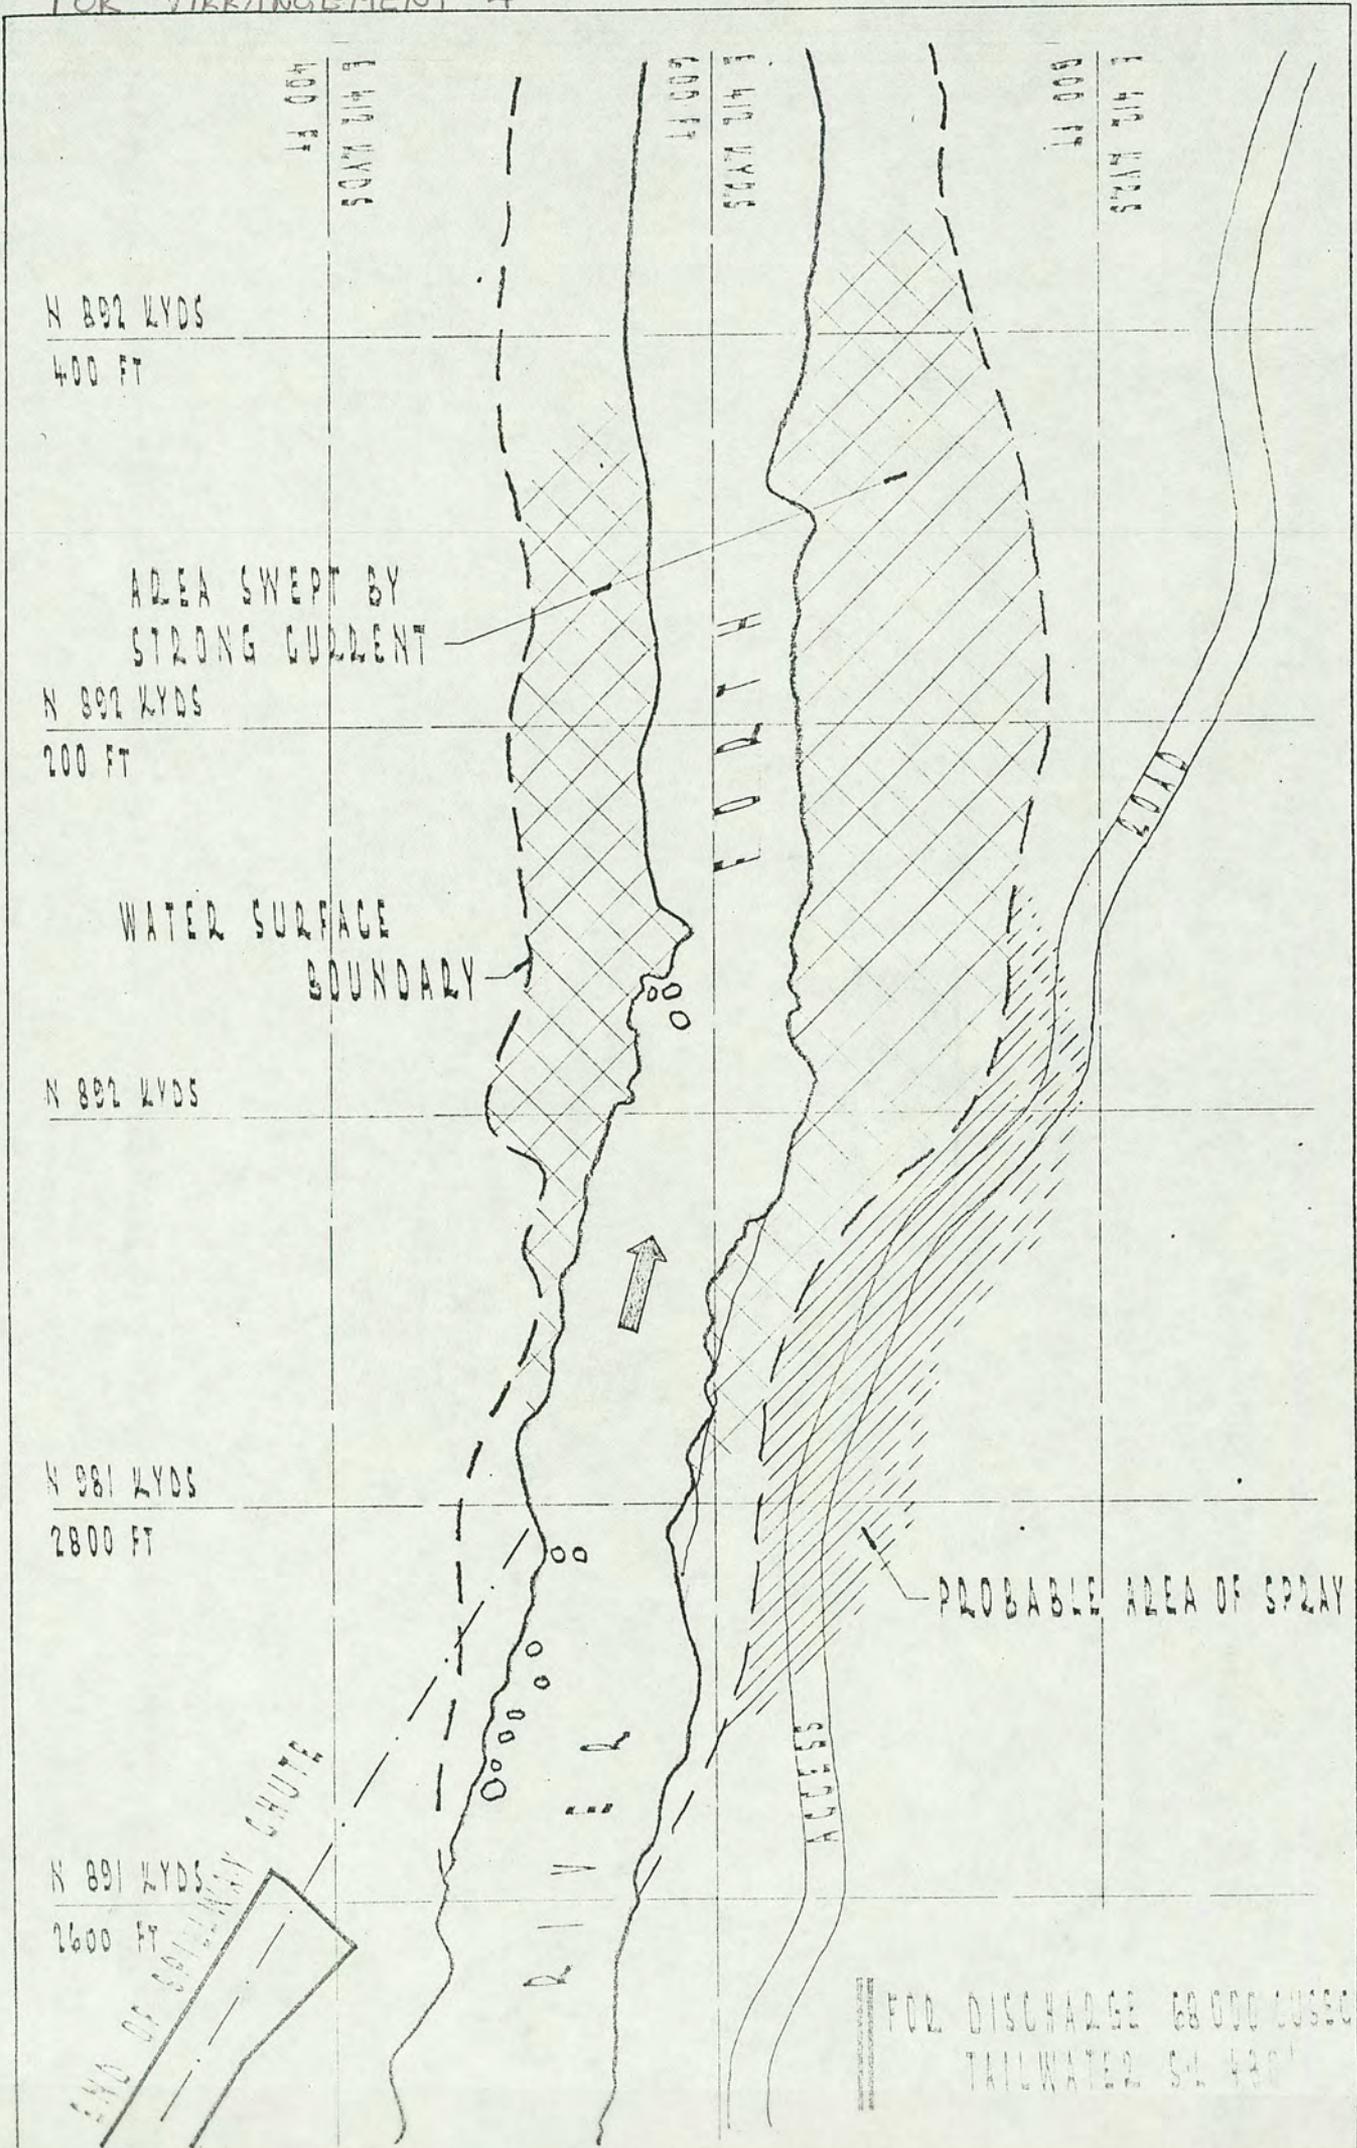
CETHANA DAM SPILLWAY
MODEL STUDIES

FOR ARRANGEMENT 4

CONDITION WITH SPILLWAY DISCHARGING

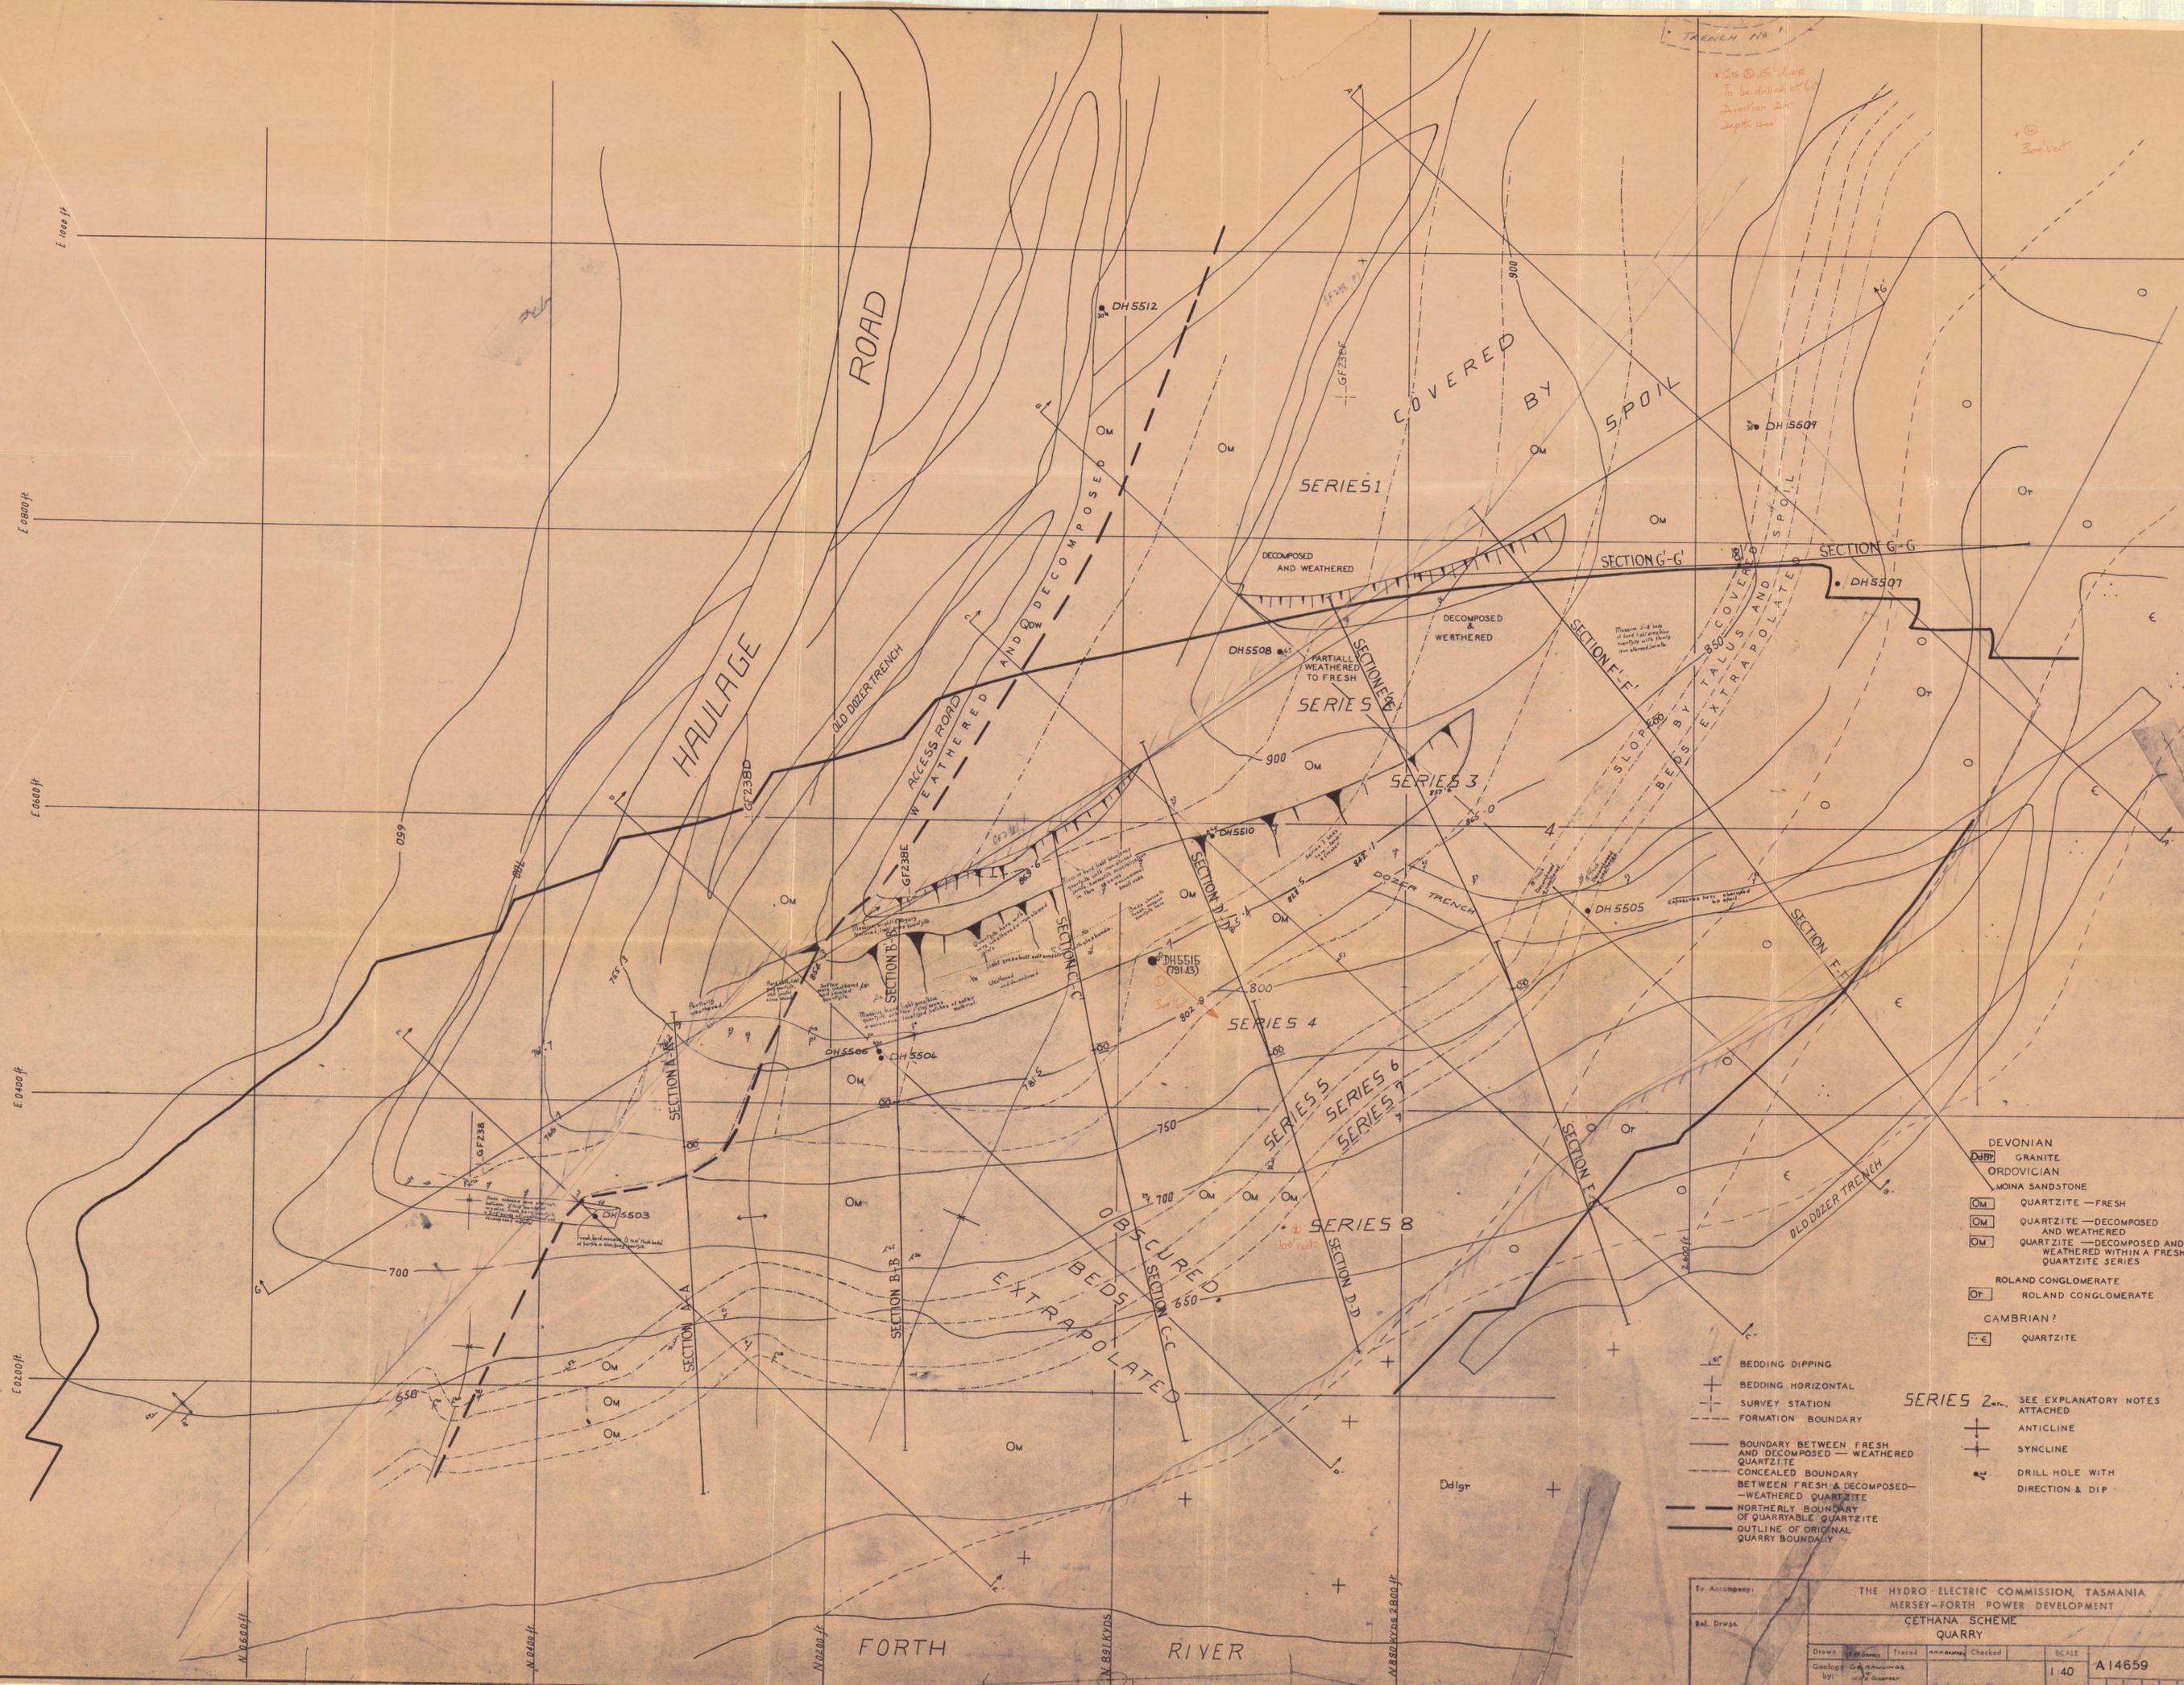
Rock to North (left) of Fault I mainly deeply weathered quartzites

To Accompany:		THE HYDRO-ELECTRIC COMMISSION TASMANIA			
Name of Client:		MERSEY FORTH POWER DEVELOPMENT			
		CETHANA QUARRY			
Ref. Drawings:		GEOLOGICAL SECTIONS A - F			
Drawn	G.E.R.	Traced	<i>[Signature]</i>	Checked	G.E.M.
Geology		by:	G.E. Rawlings	Geologist in Charge	
AI4022 - Geology		SCALE		100 Ft	AI4062
				to	
				1 Inch	
				1:1200

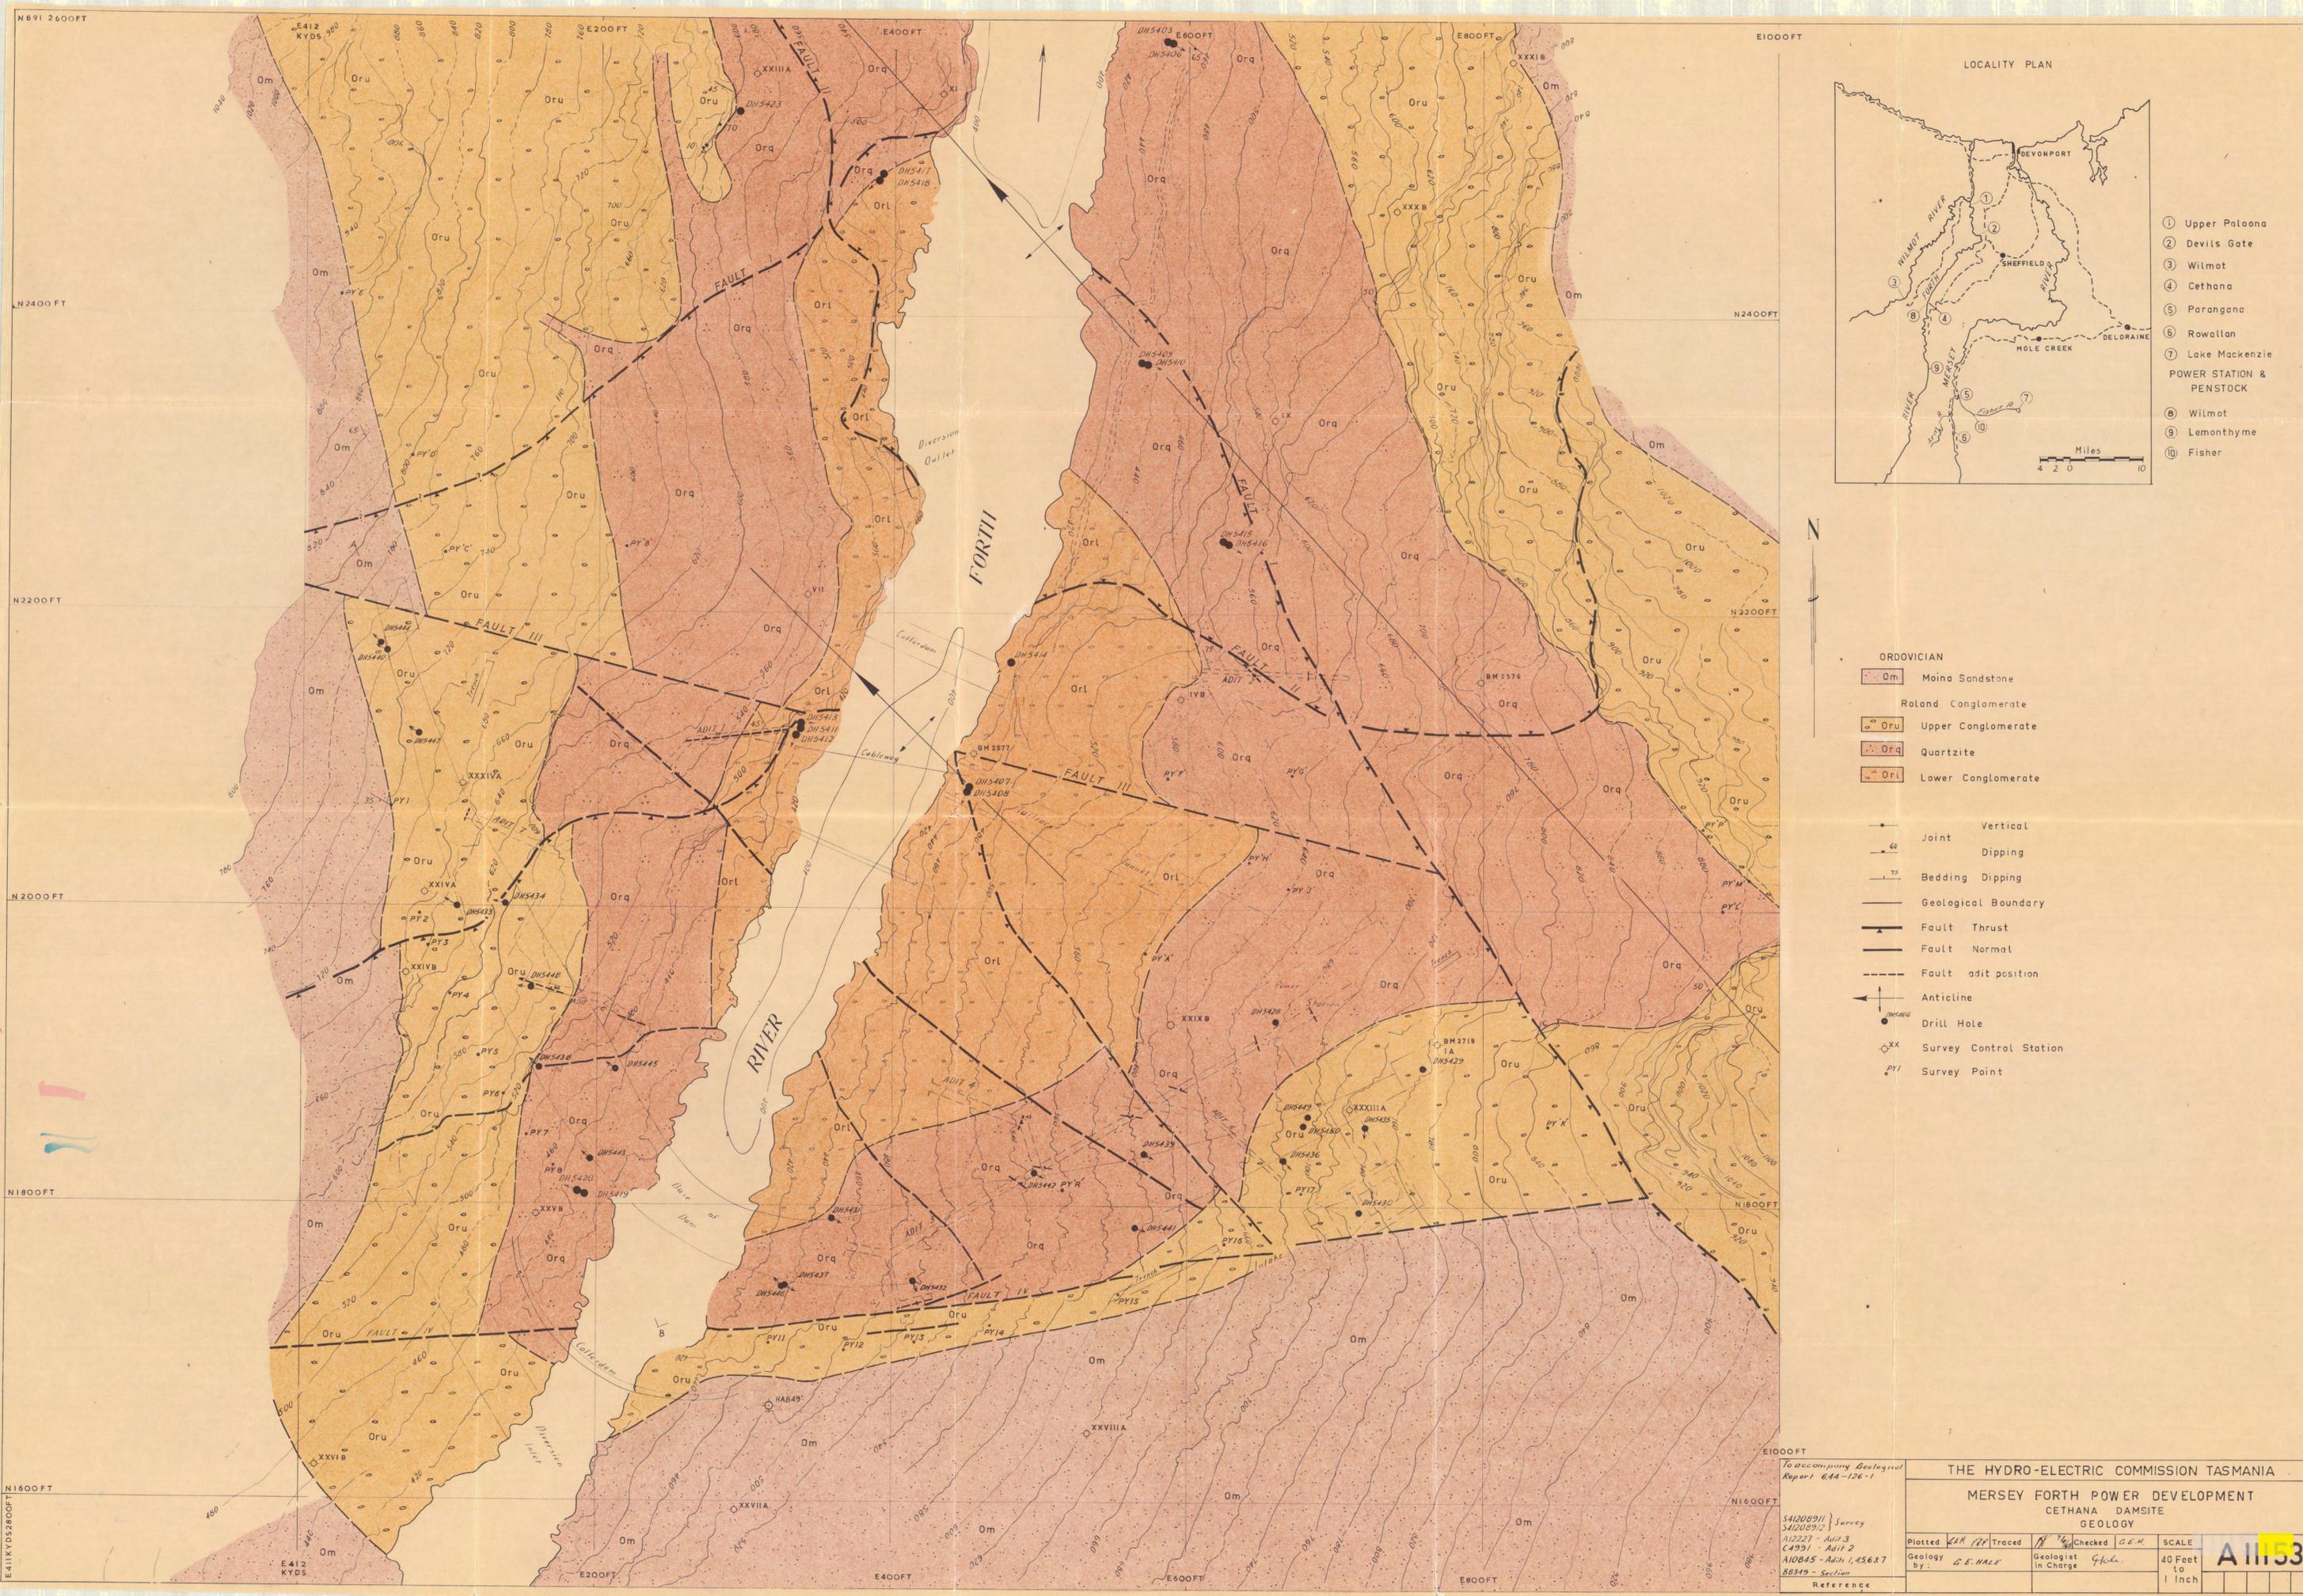
C Redrawn		6/1/04	
THE HYDRO-ELECTRIC COMMISSION TASMANIA			
MERSEY FORTH POWER DEVELOPMENT			
CETHANA DAMSITE			
GEOLOGY			
To Accompany: Geological Report G44-Ceth-3	Drawn: 47	Traced: R. K. G.	Checked: AER
Ref. Drawgs: X5759 - Survey	Geology: G.P. Rawlings	Geologist in Charge: G. G. G.	SCALE: 20 Feet to 1 Inch
A10845 Adit 14, 5 & 7	A12227 Adit 3	B9203 Diversion Tunnel	A12390
C9563 Adit 6	C9563 Adit 8		1:240
